Emissions Recall

Code: 24CV

Subject Inlet Air Box Housing Snow Flap Replacement & Oxygen Sensor Inspection/Replacement

Affected Vehicles U.S.A. : 2009-2014 MY Volkswagen 2.0L TDI Engine Vehicles (Generation I)

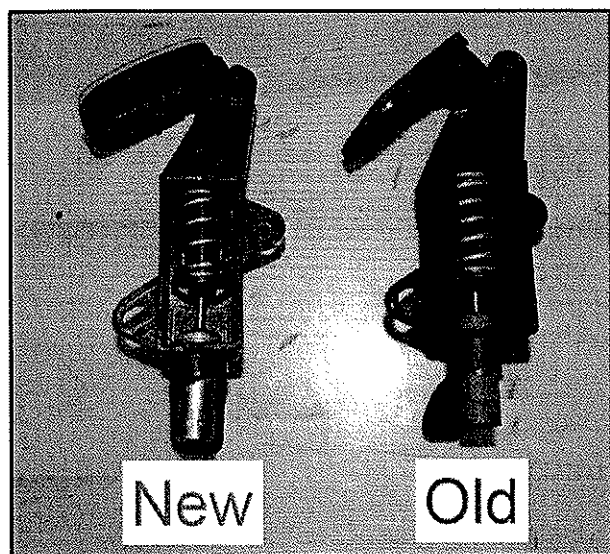
The new snow flap when at rest and at normal room temperature (70 F or 21 C) may appear to be extended in the closed position further than the old flap. This condition is normal.

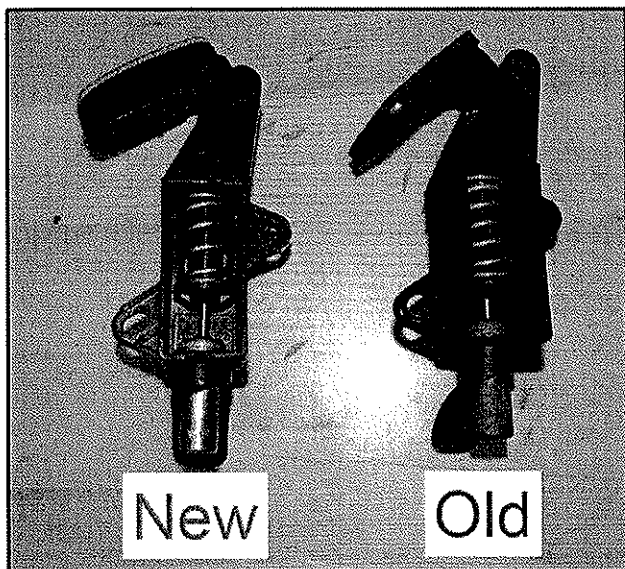
The new Snow Flap when at rest and at normal room temperature (70 F or 21 C) may appear to be extended in the closed position further than the old flap. This condition is normal.
